North Coast Interceptor

**Sewer Pipe Evaluation:
Fiberglass and Asbestos
Cement Pipe Analysis**

January 19, 2009

Subject: North Coast Interceptor
Sewer Pipe Evaluation: Fiberglass and Asbestos Cement Pipe Analysis
P. O. No. 06655
Project No. 0801832

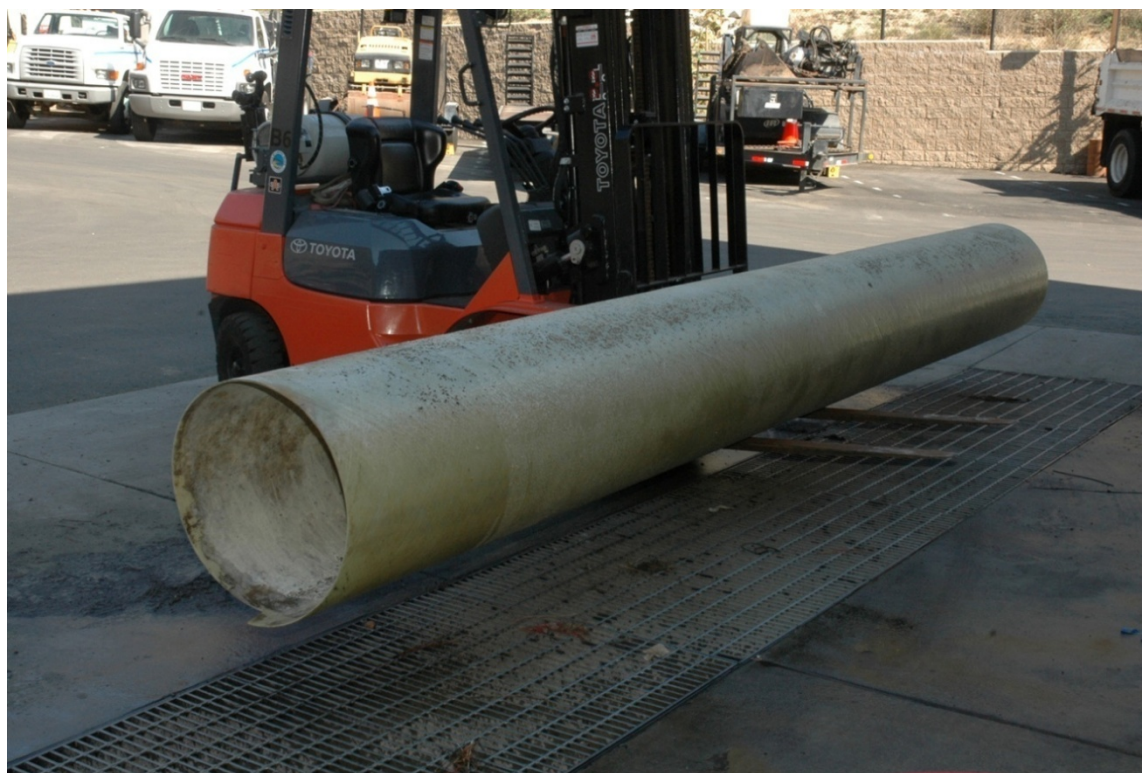
DSC_8103

Exponent inspected the subject pipe sections on 30th September 2008 at the City of Laguna Beach Waste Water Division maintenance facility. We inspected two filament-wound fiberglass pipe sections, one approximately 18-feet in length (Figures 1 and 2), and the other, which includes a bell and spigot joint, approximately 13-feet in length (Figures 3 and 4). Each section of fiberglass pipe measured approximately two feet in diameter and approximately 0.2 inch in wall thickness. A label identifying the pipe as A.O. Smith –Inland Big Thread™, and indicating a nominal pressure rating of 50 psi, a diameter of 24-inches, and a release date of 4th January 1979 is present on the 13-foot section (Figure 5). A separate A.O. Smith-Inland label is

Figure 1. Overall view of 18-foot fiberglass pipe section.

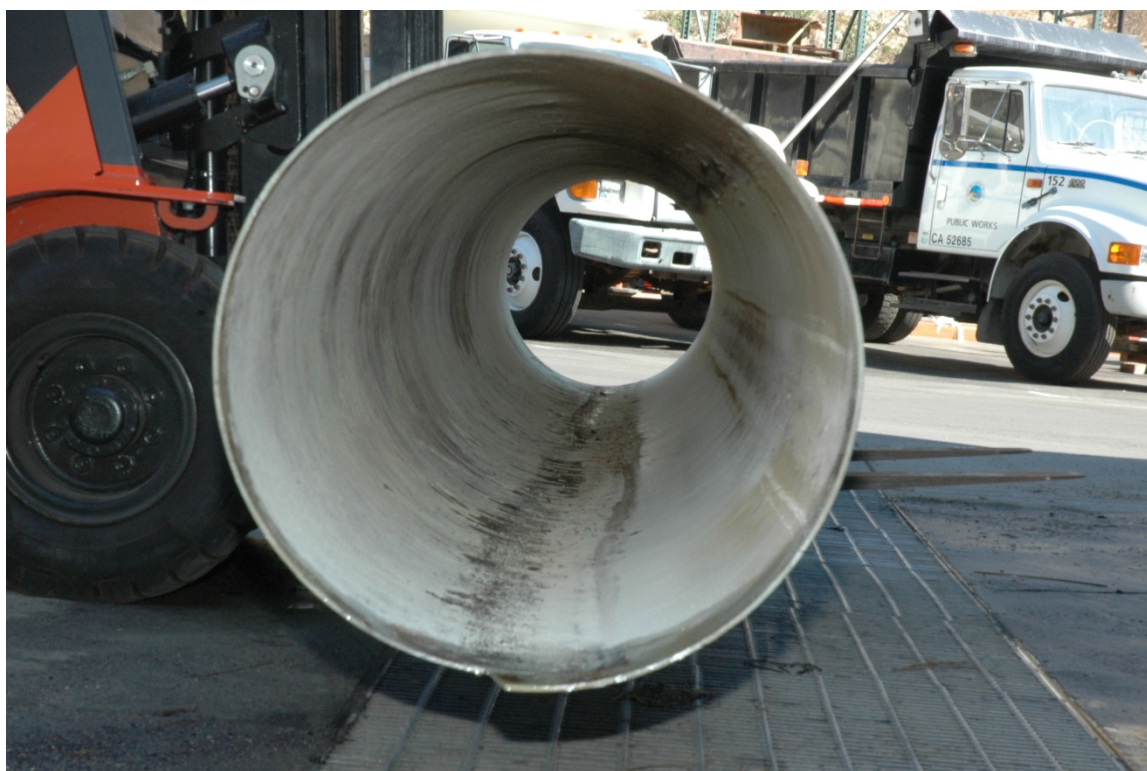
DSC_8104

Figure 2. Interior of 18-foot fiberglass pipe section.

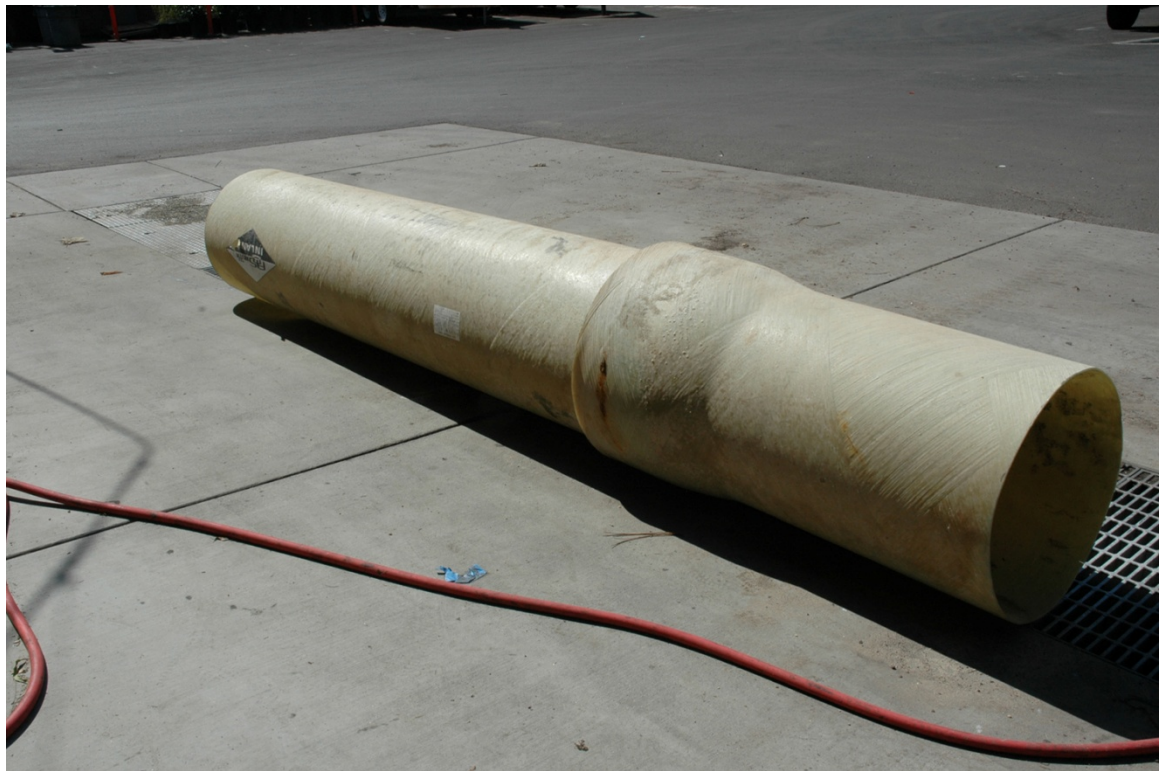
DSC_8202

Figure 3. Overall view of 13-foot fiberglass pipe section.

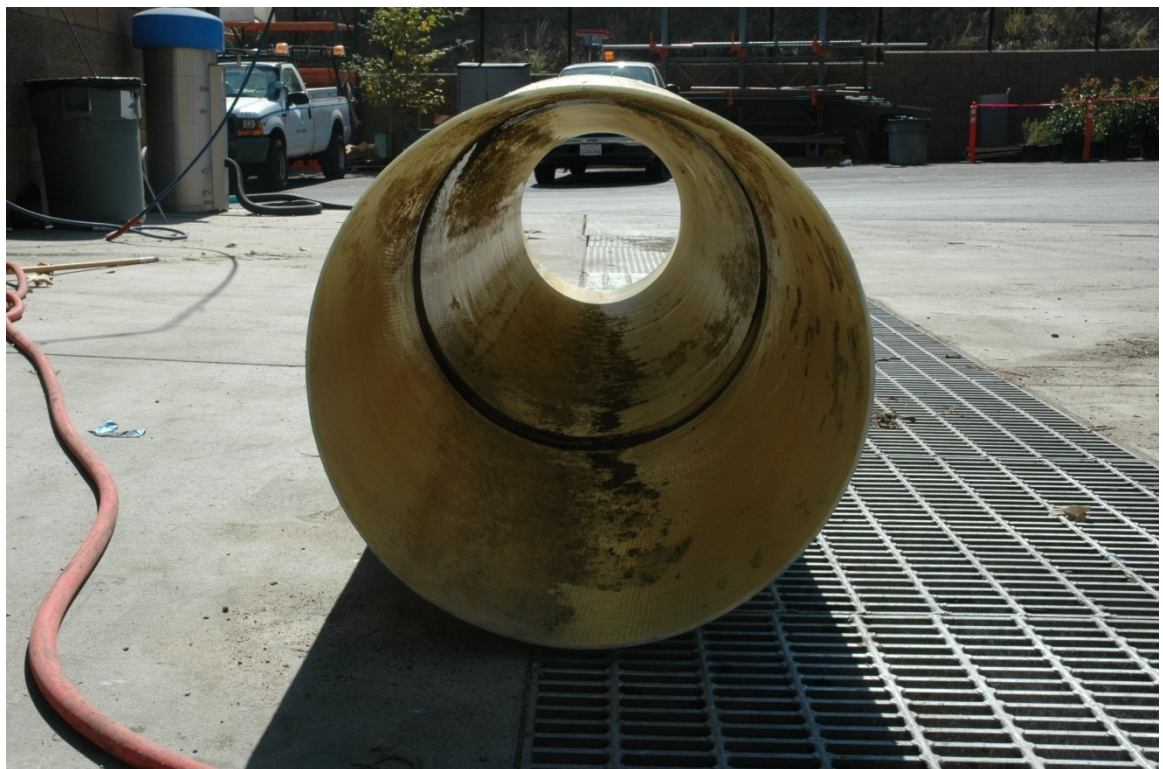
DSC_8207

Figure 4. Interior of 13-foot fiberglass pipe section.

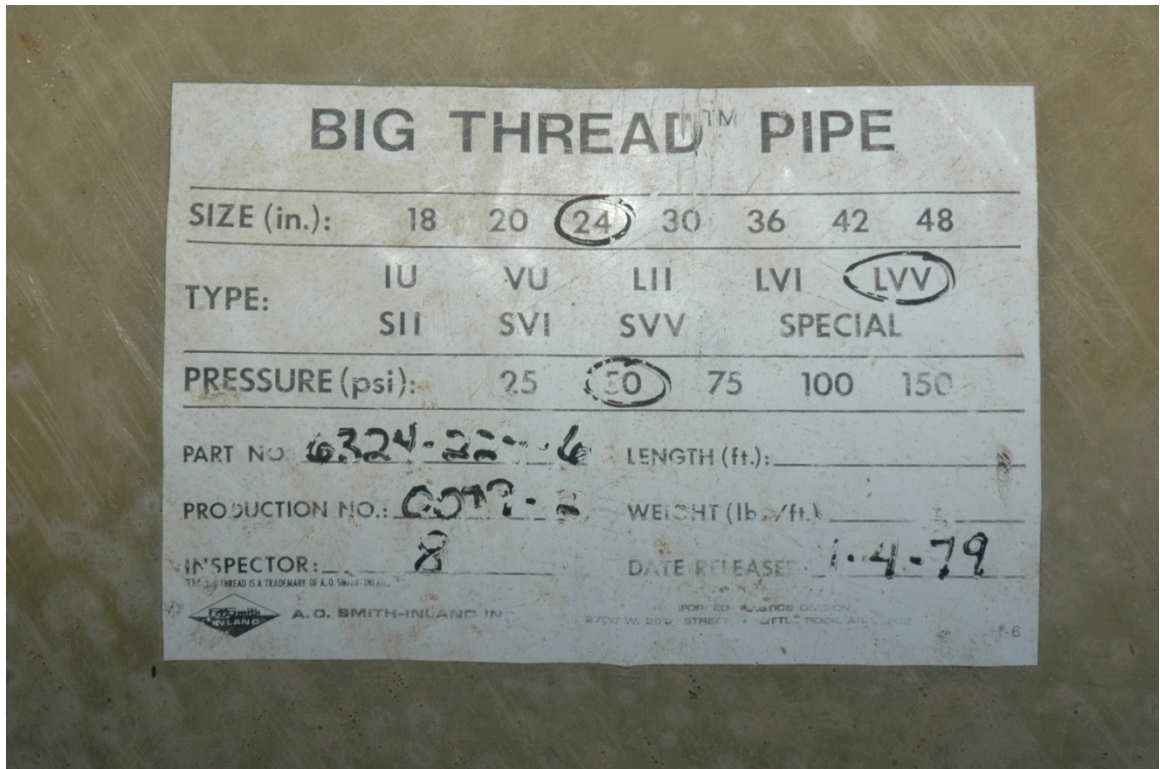
DSC_8128

Figure 5. Big Thread™ label on 13-foot fiberglass pipe section.

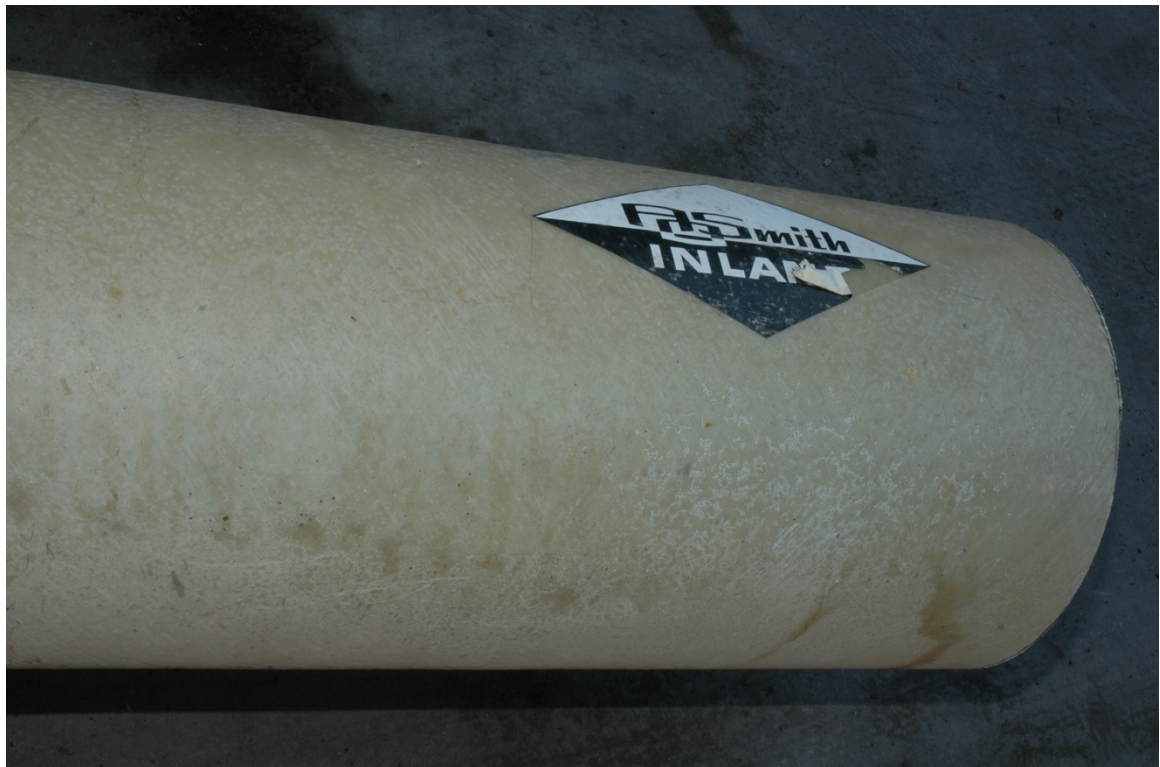
DSC_8129

also present on this pipe (Figure 6). No labels were observed on the 18-foot fiberglass pipe. Visual inspection of the pipe did not reveal any cracks or deterioration. One-foot long ring samples were cut from one end of the 18-foot pipe and from the end of the pipe with the A.O. Smith Inland label for further testing and evaluation (Figures 7 and 8).

Figure 6. A.O. Smith Inland label on 13-foot fiberglass pipe section.

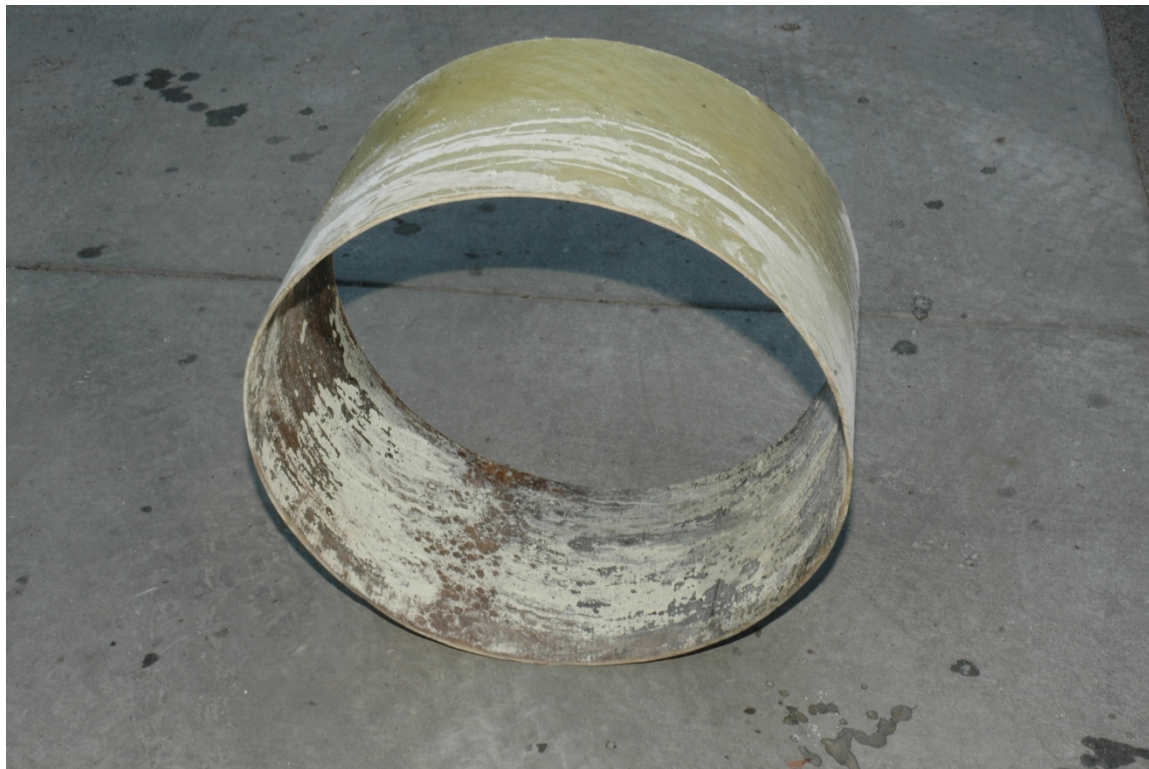
DSC_8116

Figure 7. Section cut from end of 18-foot fiberglass pipe.

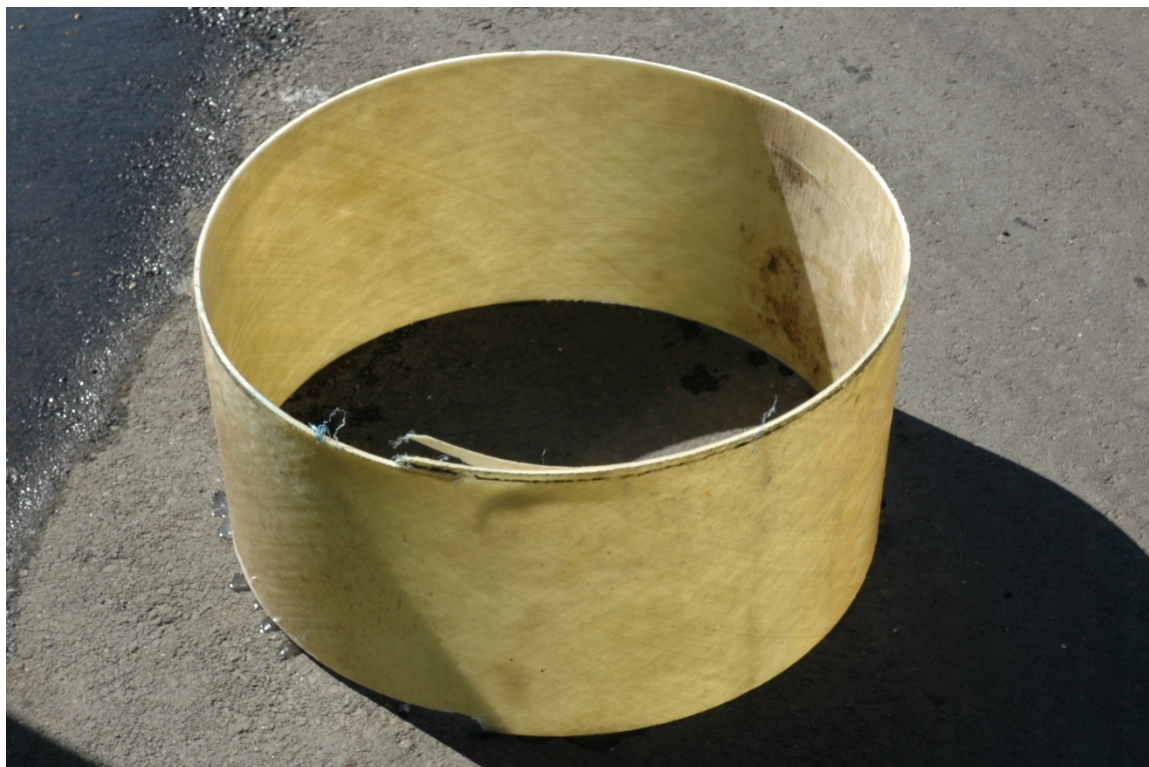
DSC_8212

Figure 8. Section cut from fiberglass pipe with A.O. Smith Inland label.

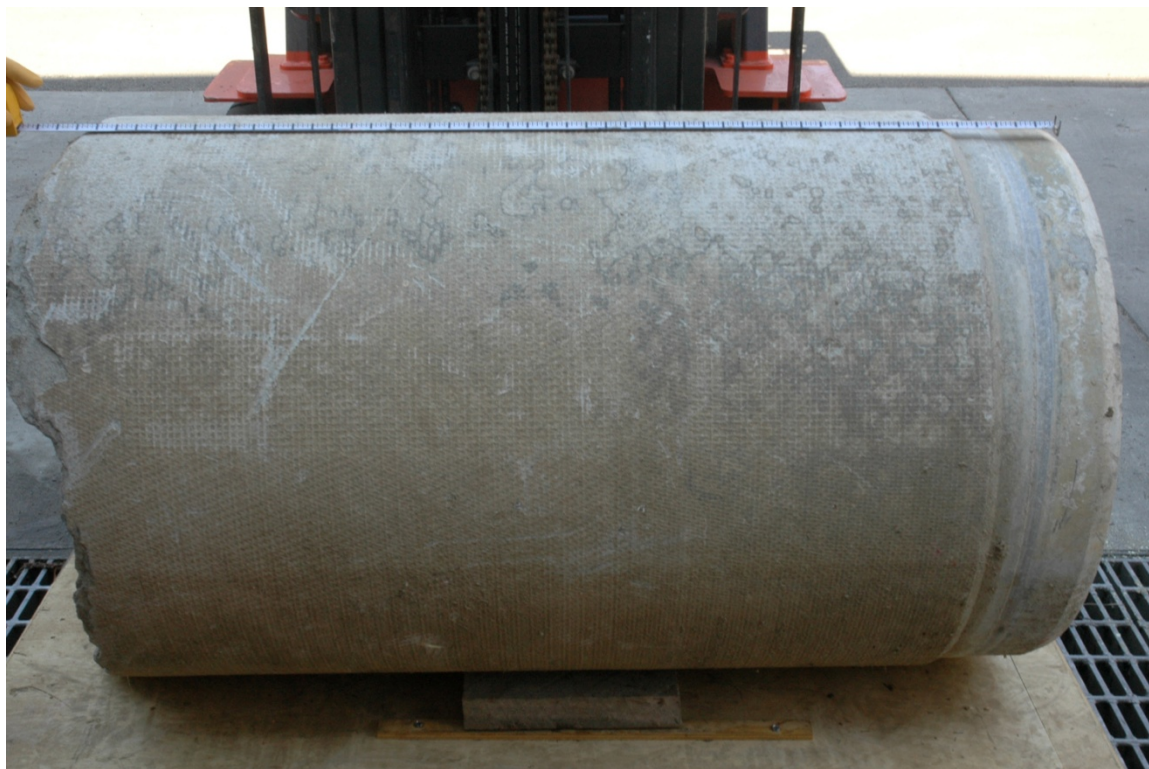
DSC_8136

The asbestos cement pipe section was approximately 4 feet long, with an outer diameter of approximately 31 inches and a wall thickness of 2 inches (Figure 9 and Figure 10). One end of this pipe comprised the spigot and the other end is comprised of a cut surface created during the field removal process. Away from the cut end, the pipe appeared to be in good condition. A one-foot ring section was cut away from the ends of the pipe for mechanical testing, and a smaller section approximately six inches square was cut for petrographic analysis (Figure 11 and Figure 12).

Figure 9. Overall view of asbestos cement pipe section.

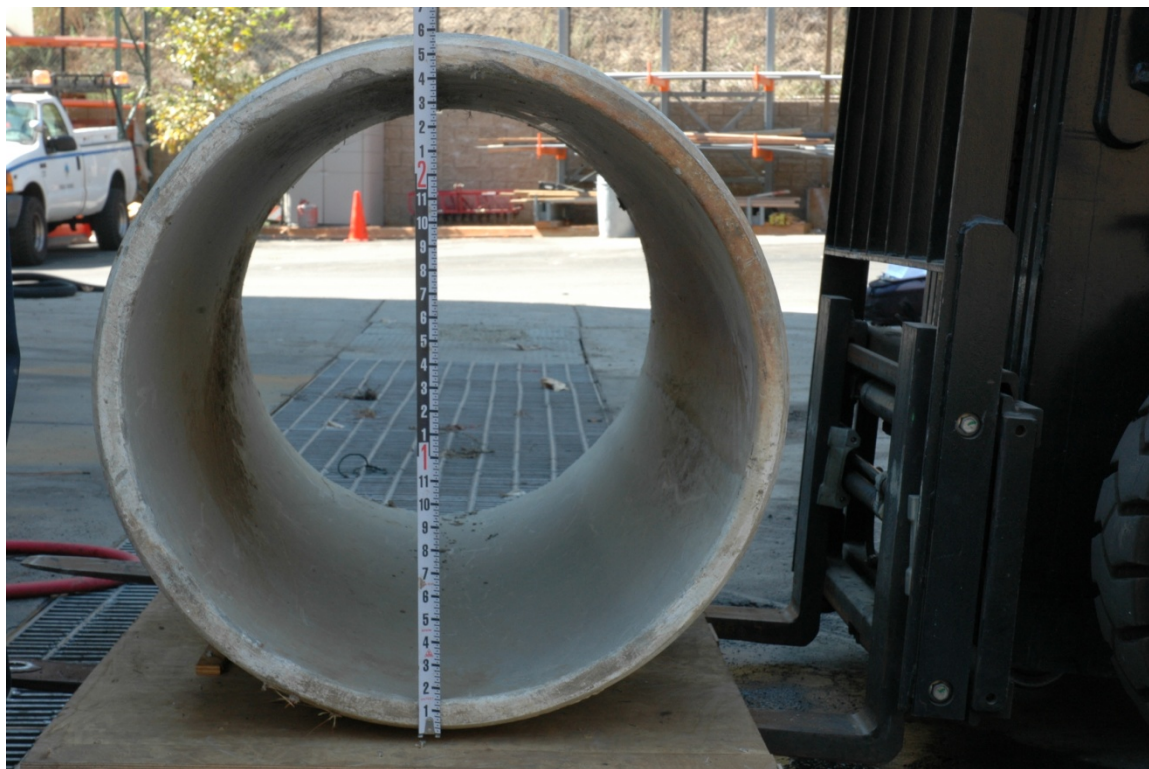
DSC_8138

Figure 10. Interior of asbestos cement pipe section.

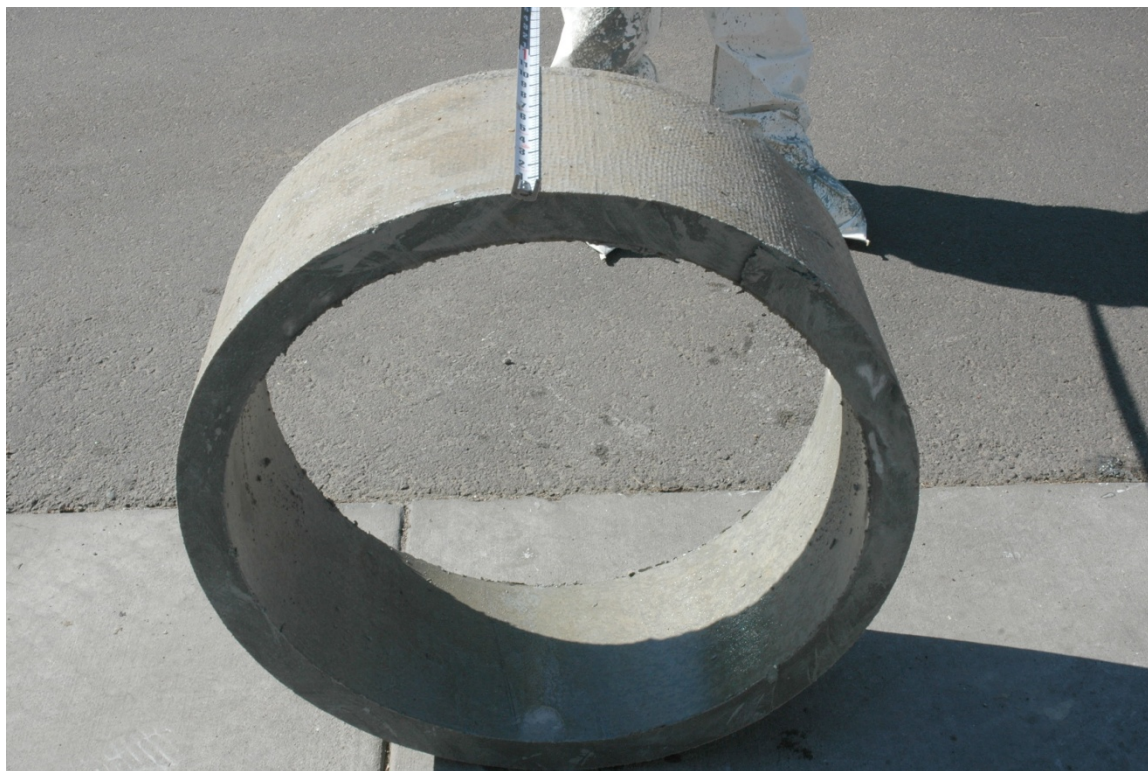
DSC_8215

Figure 11. Ring sample removed from asbestos cement pipe.

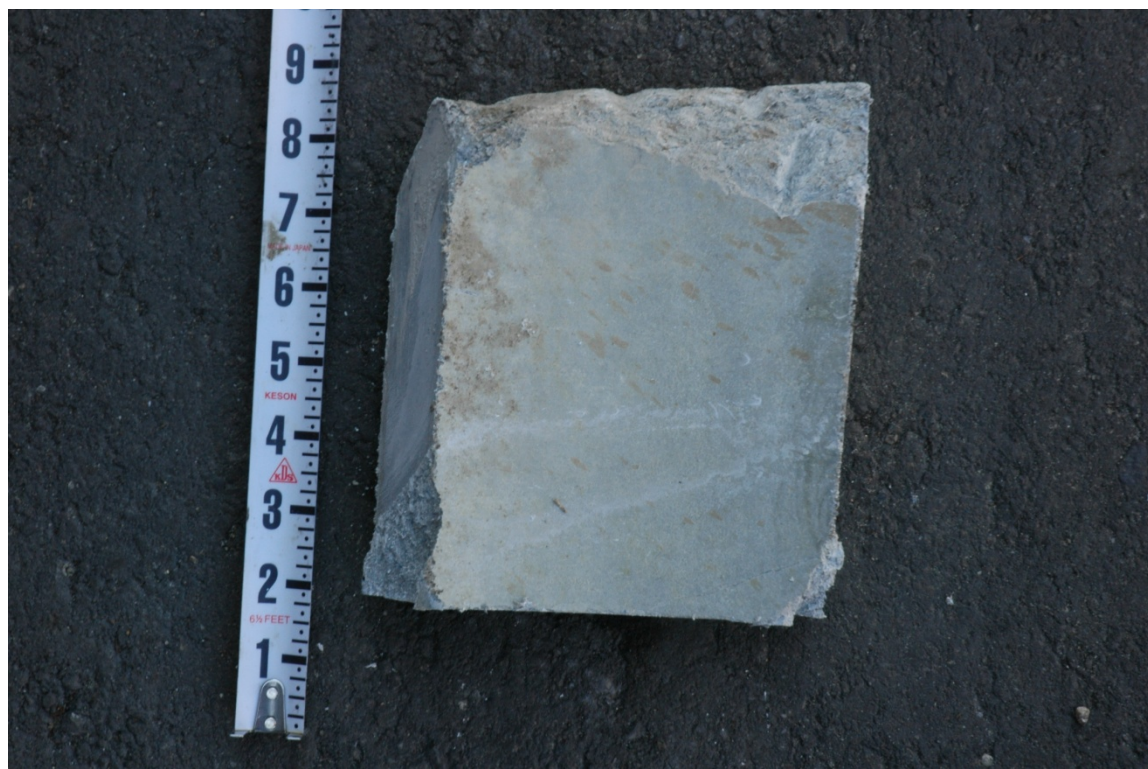
DSC_8227

Figure 12. Petrographic sample removed from asbestos cement pipe.

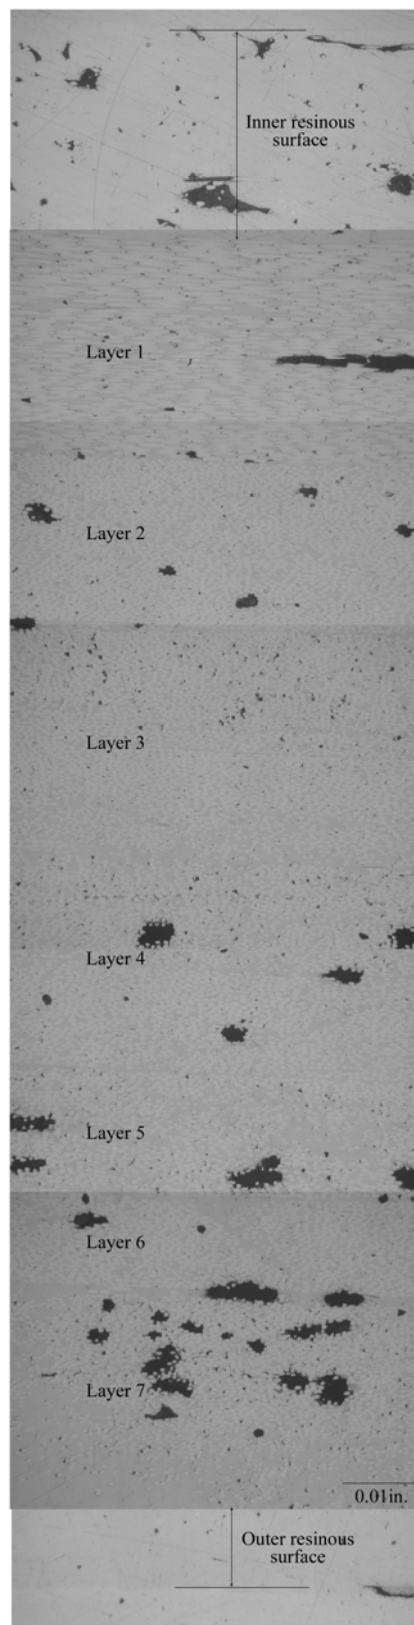
Optical microscopy of the fiberglass pipe cross-section revealed resin-rich material at the outer and inner surfaces and multiple layers of fiberglass plies, most with fiber orientation of approximately $\pm 45^\circ$ to the pipe axis, and a layer of hoop fiber near the inner surface (Figure 14). We did not observe fiber or matrix cracking or evidence of chemical attack. Voids were observed in other parts of the polished fiber-glass pipe transverse-section (Figure 15), but some degree of porosity is typical of fiberglass material.

Figure 14. Microstructure of the fiberglass pipe transverse cross-section.

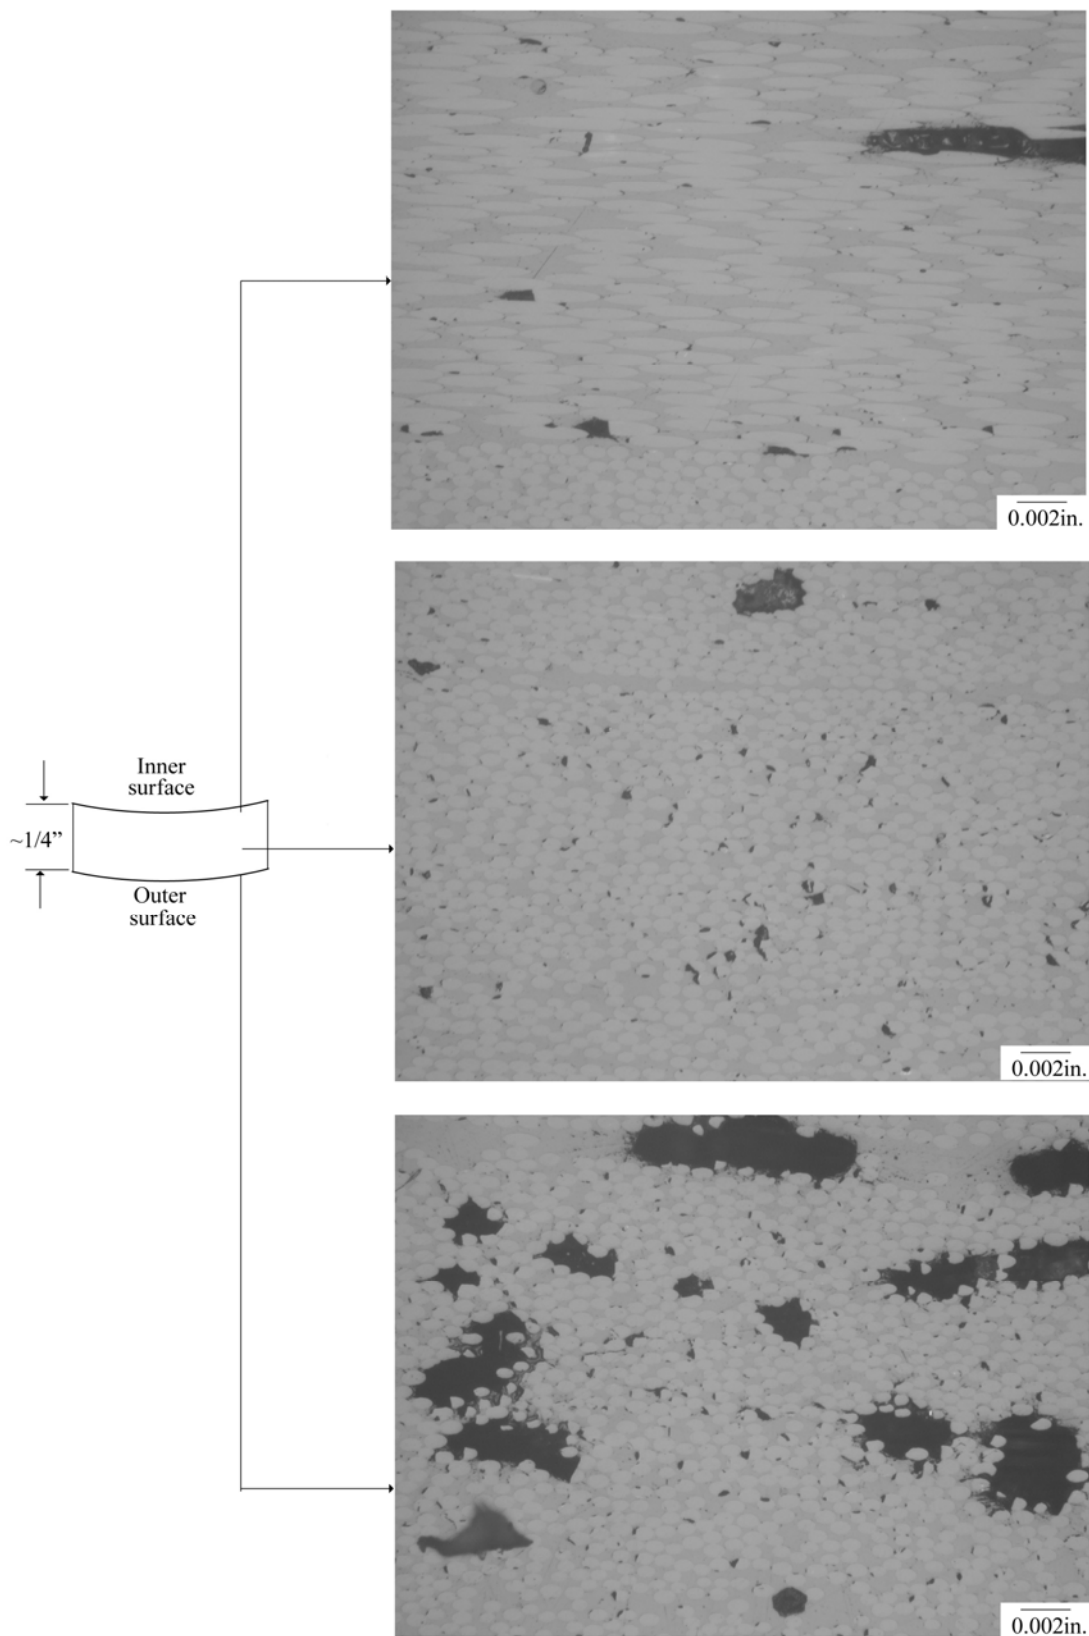
Figure 15. Microstructures obtained from three different regions of the fiberglass pipe cross-section.

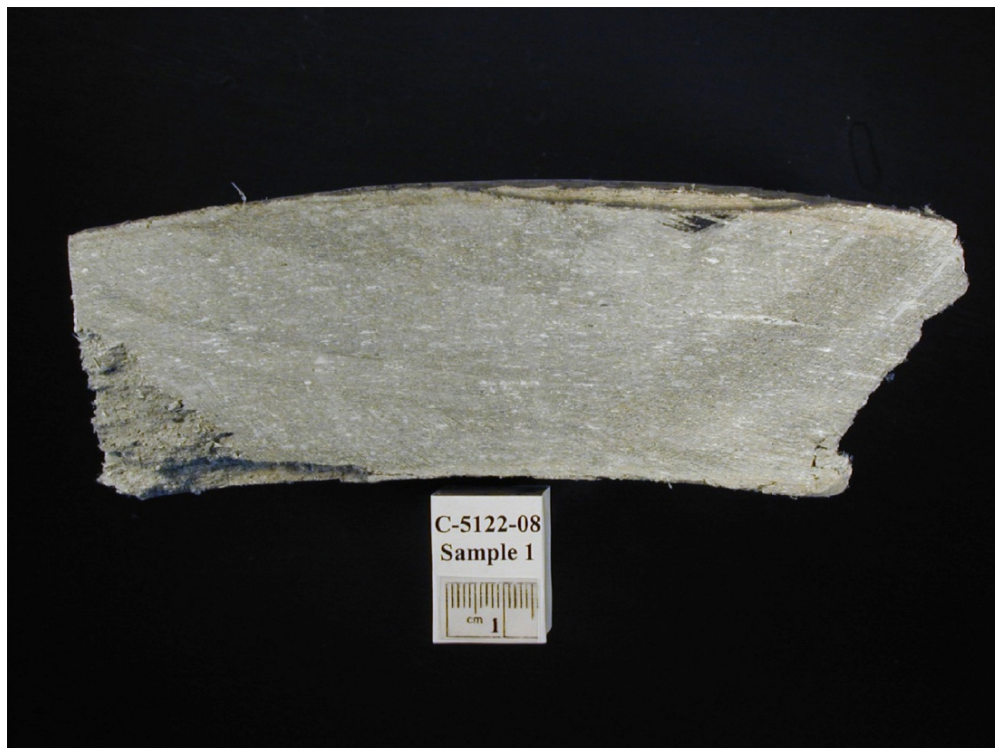
Petrographic analysis of a section removed from the asbestos cement pipe (Figure 16) revealed that it is comprised of a uniform distribution of very fine crushed sand, Portland cement and asbestos fibers. No fly ash materials were detected. The sand was composed of quartz with very low amounts of calcite and mica. The particle size of the sand ranged from 0.15 mm to 0.02 mm (minus No. 50 sieve to minus No. 200 sieve). The sand materials appeared properly shaped, uniformly distributed, and very hard.

Based on the petrographic examination, the asbestos cement pipe appeared to have excellent overall strength properties. While some areas along the exterior surface were fairly soft, these did not extend into the pipe for any significant depth. The pipe was properly cured as indicated by the degree of Portland cement hydration by thin section analysis and observed strength of the pipe. No macro or micro cracks were observed. No evidence of secondary deposits or deleterious reactions was observed.

Figure 16. Cross-section from the asbestos cement small-section specimen for petrographic analysis.

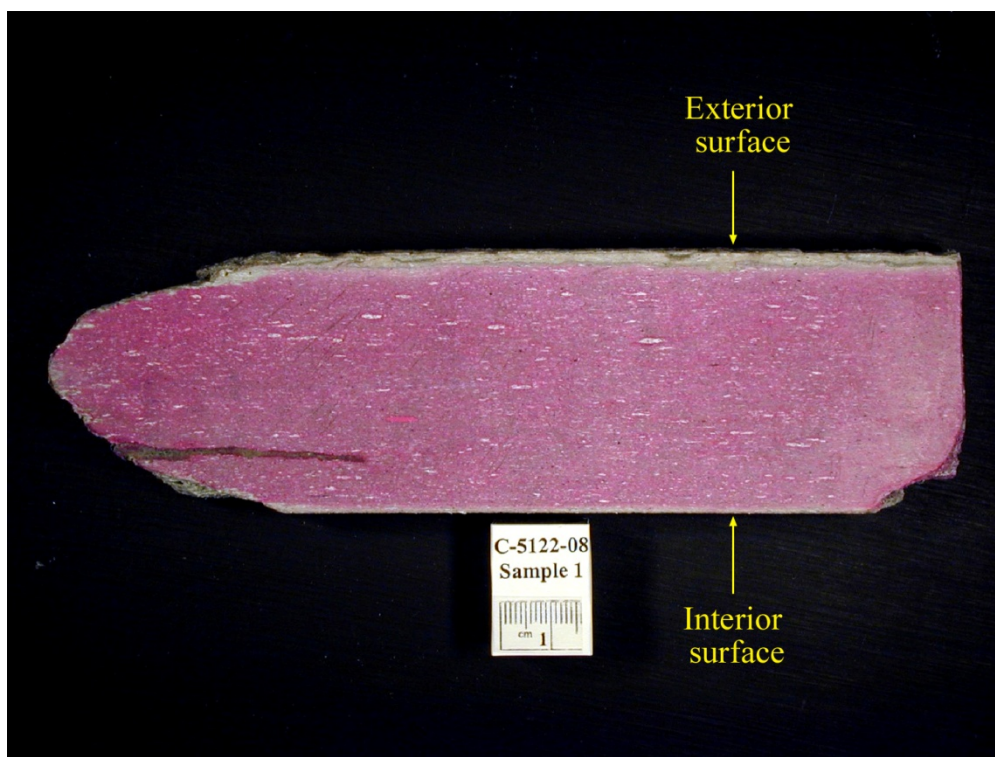
Depth of paste carbonation along the exterior surface was 1.5 to 3.5 mm by thin section analysis and 2.0 to 3.0 mm by the phenolphthalein test. The interior of the pipe was carbonated to a

depth of 1.0 to 1.5 mm by the phenolphthalein test (Figure 17). The maximum combined depth of interior and exterior carbonation is less than 10% of the pipe wall thickness.

Figure 17. Phenolphthalein staining to show extent of carbonation.
