CORNER RECORD

2007-1153A

City of LAGUNA BEACH County of ORANGE, California

Brief Legal Description CENTER LINE INTERSECTION OF CARMELITA STREET AND AGATE STREET

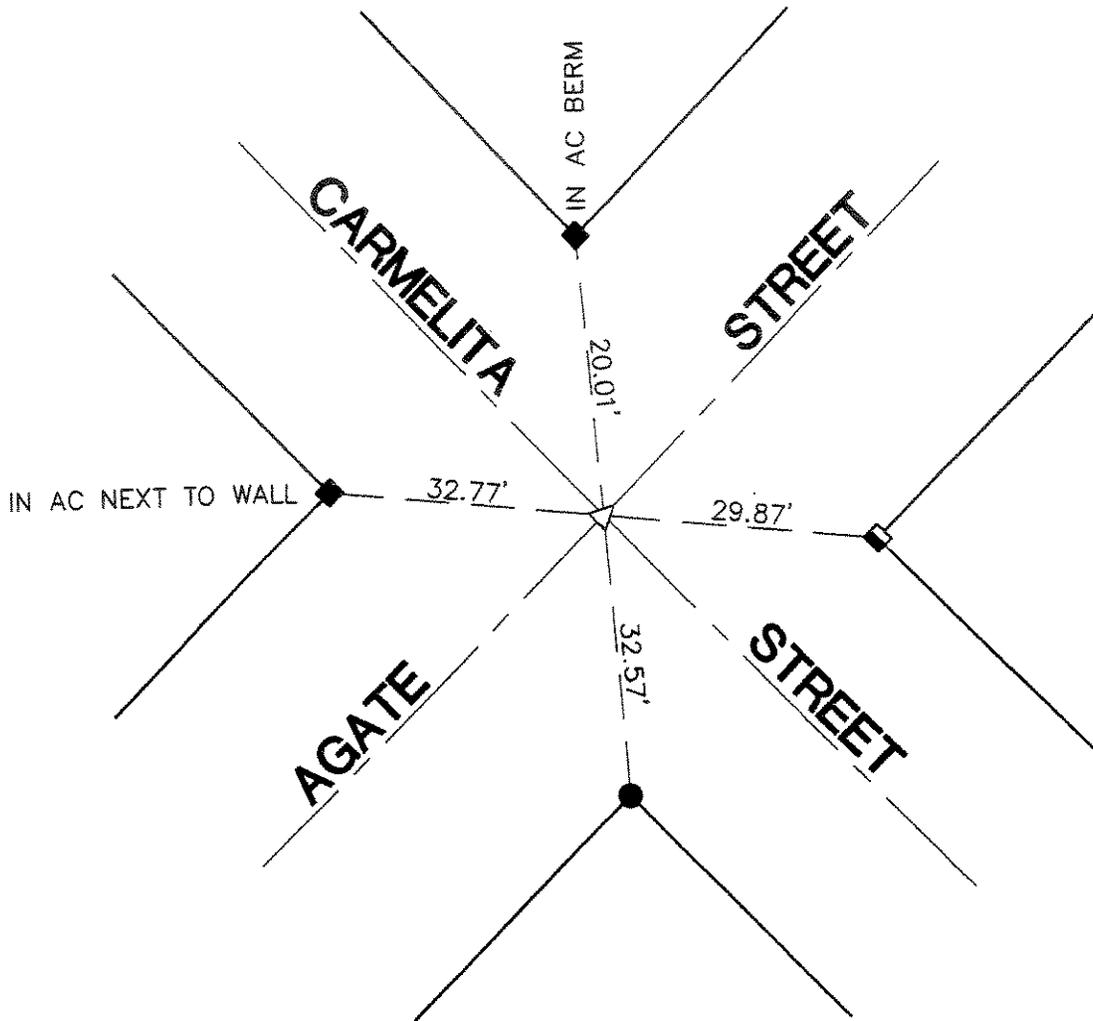
A description of the physical condition of the monument as found and as set or reset: SEE PAGE 2.
FOUND REBAR ON ACCEPTED AS CENTERLINE INTERSECTION OF CARMELITA STREET AND
AGATE STREET. NO REFERENCE.

- △ FOUND REBAR, DOWN 0.1', NO REF.
- SET CHISELED "X" ON CONCRETE FIRE HYDRANT PAD
- SET PK
- ▣ SET NAIL ON SIDE OF POWER POLE # 23101

NOTE: ALL TIES ARE TEMPORARY. PERMANANT TIES WILL BE SET AFTER CONSTRUCTION.
