TECHNICAL SSO REPORT

City of Laguna Beach WDID 9SSO10653

Subject: North Coast Interceptor - SSO Event #863226

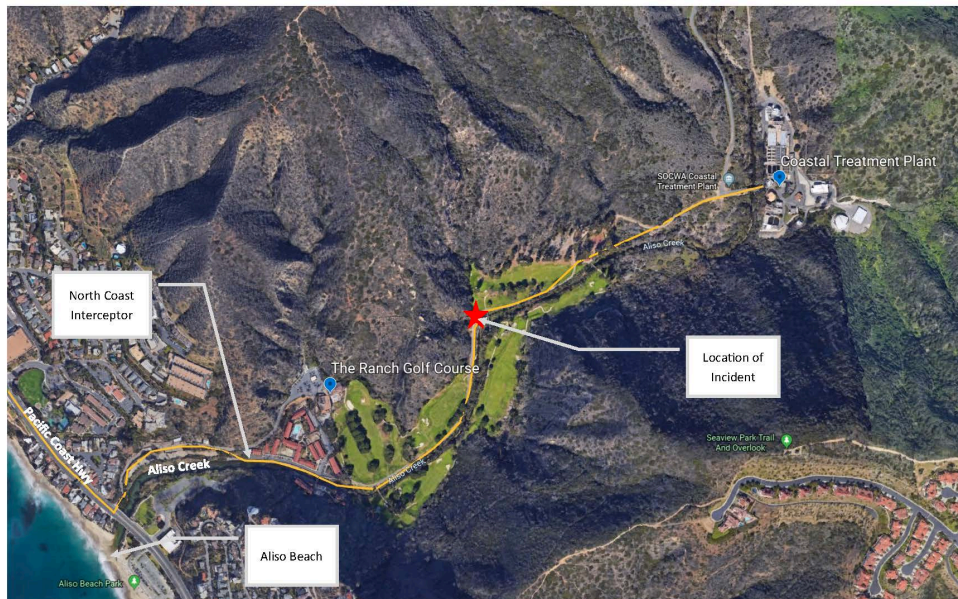
Map Exhibit #2—Location of Incident

The vault is located near the 6th hole of the Ben Brown's golf course just off of the groundskeeping maintenance road. The location of the vault is at the center of a pinch-point in the canyon, where several underground utilities necessitated identification to determine which utility was leaking.

Section 1b) The map below shows the location of the vault relative to the SOCWA Coastal Treatment Plant and the Coast Highway. (See Map Exhibit #2 – Location of Incident)

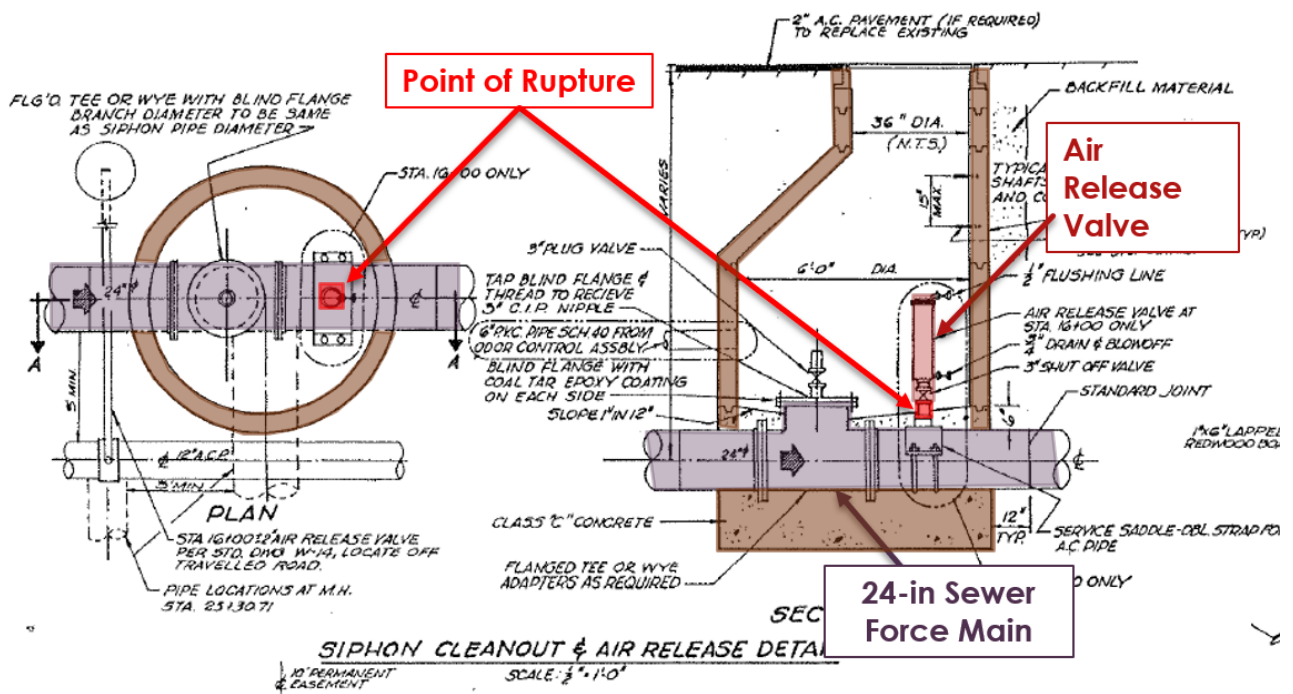
The point of failure was identified as a decommissioned air/vacuum relief valve (AVRV) vault. As discussed in more detail below, this AVRV was replaced in 2014. There is no other valve stem in the NCI system like this. It is unique because normally when an air/vac release valve assembly (or any valve assembly) is replaced, the prior assembly would be either removed or decommissioned and isolated from the active line. However, this small length of the valve stem was left intact because the bypass that would have been necessary would have caused severe disruption to the Ben Brown Golf Course and the Ranch at Laguna Beach. The bypass would have required pipe fusing operations to build a high-line pipe around the vault, which would have resulted in noise, odors, traffic, and potential property damage to the golf course maintenance pathways and the overall disruption of the Ranch and the surrounding community.

Moreover, at the time of the system replacement, the AVRV system was inspected and appeared to be in a serviceable condition. The decommissioned AVRV system was deemed to be of low risk of failure since gases were no longer circulating in the system to cause corrosion.

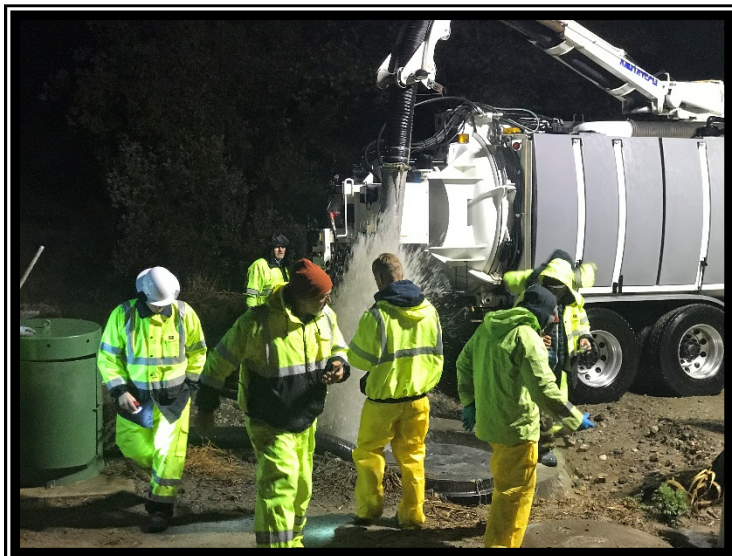
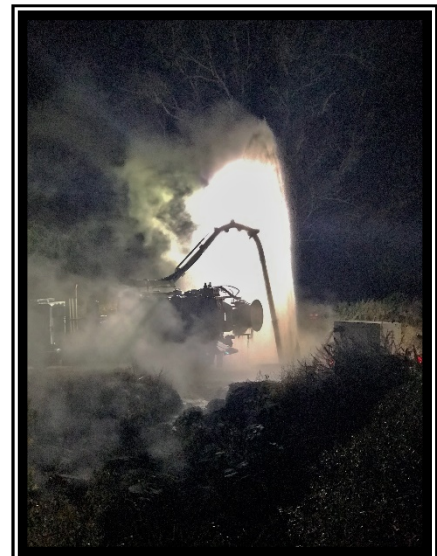
In the first evening of 11/27/19, Water Quality staff worked with JEC to attempt to evacuate the vault during the nighttime low-flow period. However, the team was unable to evacuate water quickly enough to gain a visual confirmation of the source of the leak. Despite the use of pumps and vactors, the hydraulics, unique to the vault location, resulted in an unsuccessful first effort.

Momentary Evacuation of Vault Followed by Hydraulic Rebound

Multiple methods to bypass the pressurized pipeline were evaluated location by location. The experts within the response team concluded that the best course of action was to bypass the transmission pipeline at the Bluebird SOCWA Lift Station located approximately at the Coast Highway and Calliope (see Map Exhibit #3 Bypass Location Map and Attachment 3 “Analysis of Bypassing Options”). From that location, wastewater was piped directly into the 84-inch storm drain that discharges at the Bluebird Canyon outlet. The resulting action minimized the exposure to the public and provided the successful draining of the transmission pipeline. Once the NCI was depressurized, the vault was drained, and the ruptured valve stem capped, and bulkheaded off.
