North Coast Interceptor

**Sewer Pipe Evaluation:
Fiberglass and Asbestos
Cement Pipe Analysis**

January 19, 2009

Subject: North Coast Interceptor
Sewer Pipe Evaluation: Fiberglass and Asbestos Cement Pipe Analysis
P. O. No. 06655
Project No. 0801832

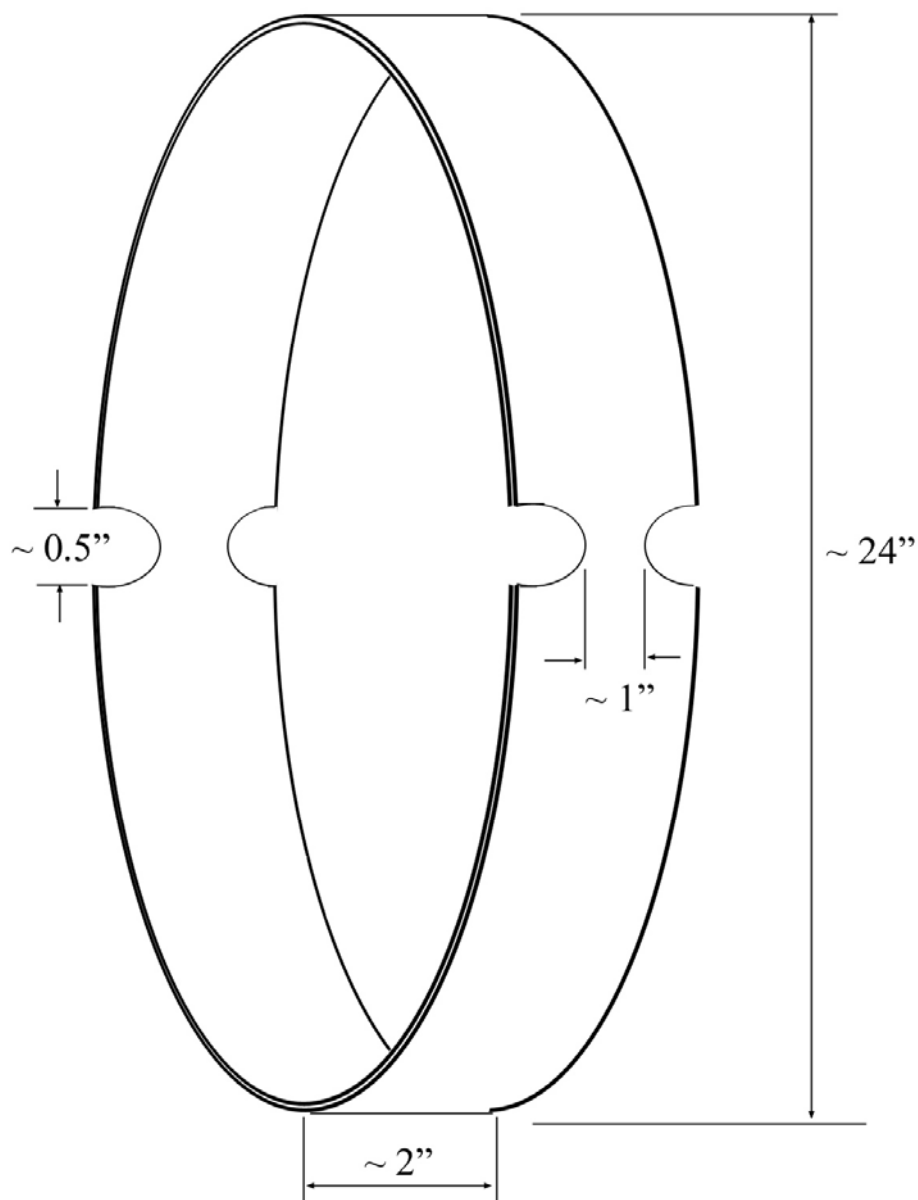
Hoop tensile strength tests were conducted on five full-circumference hoop specimens machined from the fiberglass pipe with the A.O. Smith label. Each of the hoop specimens was 2-inch wide with diametrically opposite 1-inch reduced section cut-outs (Figure 13). Prior to testing, these specimens were conditioned at 23°C and 50% relative humidity for a more than 40 hours. The tests revealed the hoop tensile strength of the subject fiberglass pipe to be approximately 35 ksi (Table 2). This corresponds to hoop strength of 7,200 lbf/inch of width, which significantly exceeds the AWWA C950 minimum short-term hoop strength requirement for 24-inch diameter, 50 psi rating fiberglass pipes of 2,400 lbf/inch of width.

Figure 13. Sketch of the specimen used for determining apparent hoop tensile strength as per ASTM D2290, procedure A standard (Not to scale).
