CORNER RECORD

Document Number 2007-1147A

Brief Legal Description CENTER LINE INTERSECTION OF SANTA CRUZ STREET AND CALLIOPE STREET

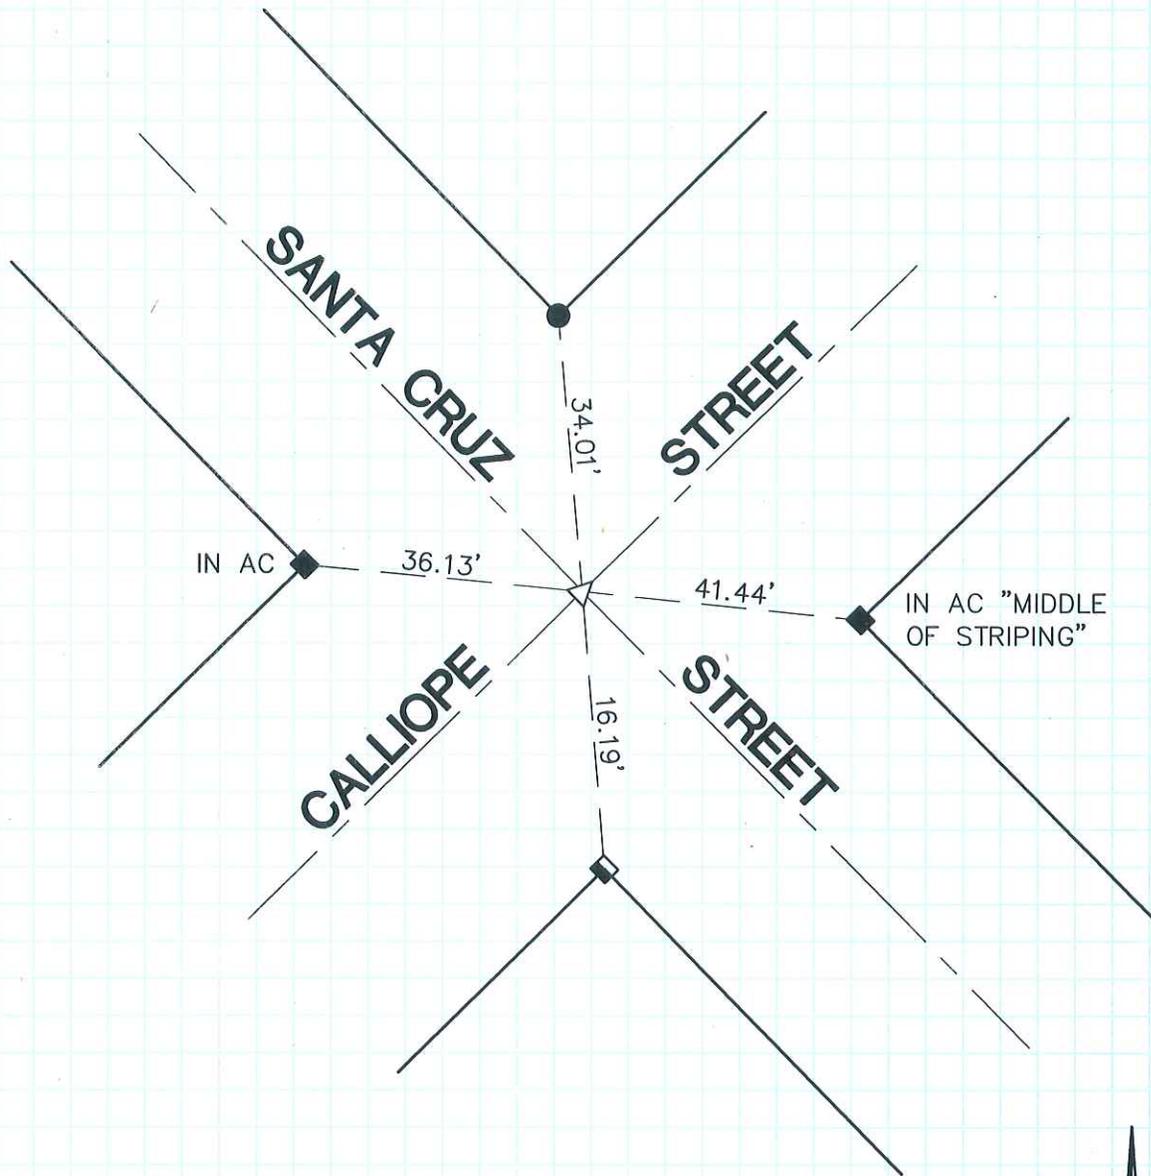
Identification and type of corner found; Evidence used to identify or procedure used to establish or reestablish the corner:
FOUND 60D NAIL

- △ FOUND 60D NAIL, NO REF., ACCEPTED AS CENTERLINE INTERSECTION SPIKE AND WASHER "L.S. 8072" TO BE SET AFTER CONSTRUCTION.
- SET CHISELED "X" ON CONCRETE PAD
- SET PK
- ▣ FOUND BRASS NAIL & TAG, NO NUMBER, ON TOP OF CURB FOR CATCH BASIN, NO REF.

NOTE: ALL TIES ARE TEMPORARY. PERMANANT TIES WILL BE SET AFTER CONSTRUCTION.
